**HAZARDOUS MINE OPENING
MAINTENANCE PROJECT
DSL/AMRB PROJECT NO. 93-M08**

HAZARDOUS MINE OPENING MAINTENANCE PROJECT
DSL/AMRB PROJECT NO. 93-M08

July 1994

RE: Hazardous Mine Opening Maintenance Project - Final Report

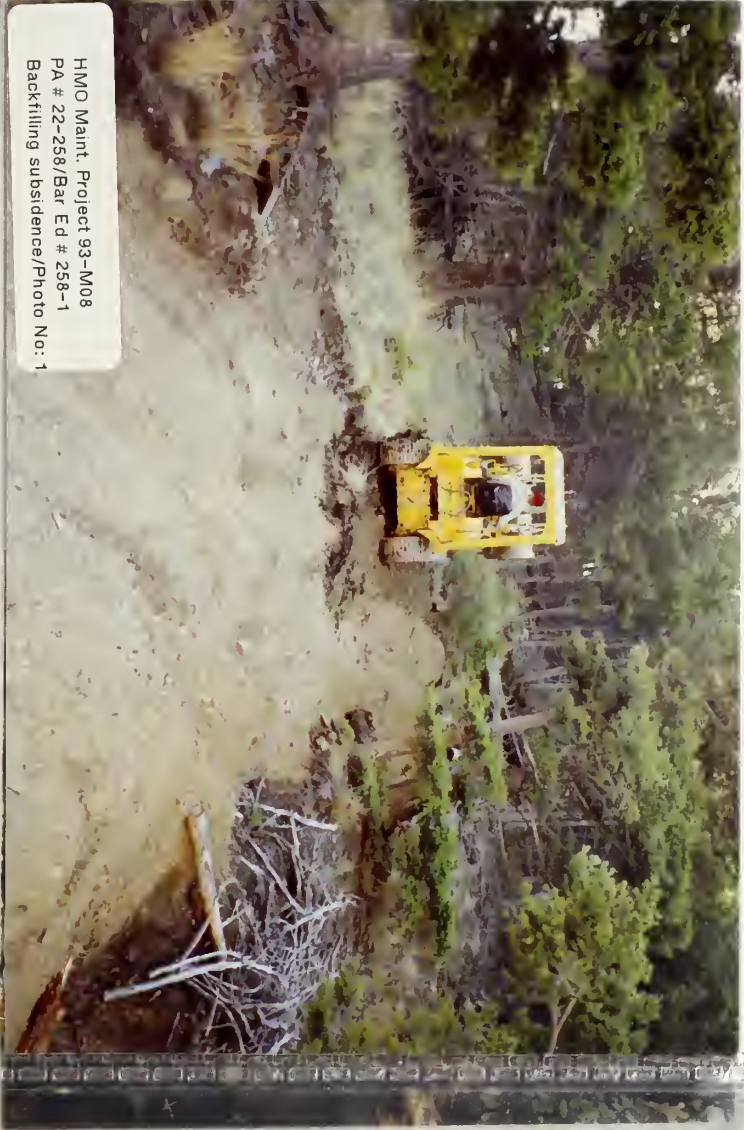
HMO Maint. Project 93-M08
PA # 22-258/Bar Ed # 258-1
Backfilling subsidence/Photo No: 1

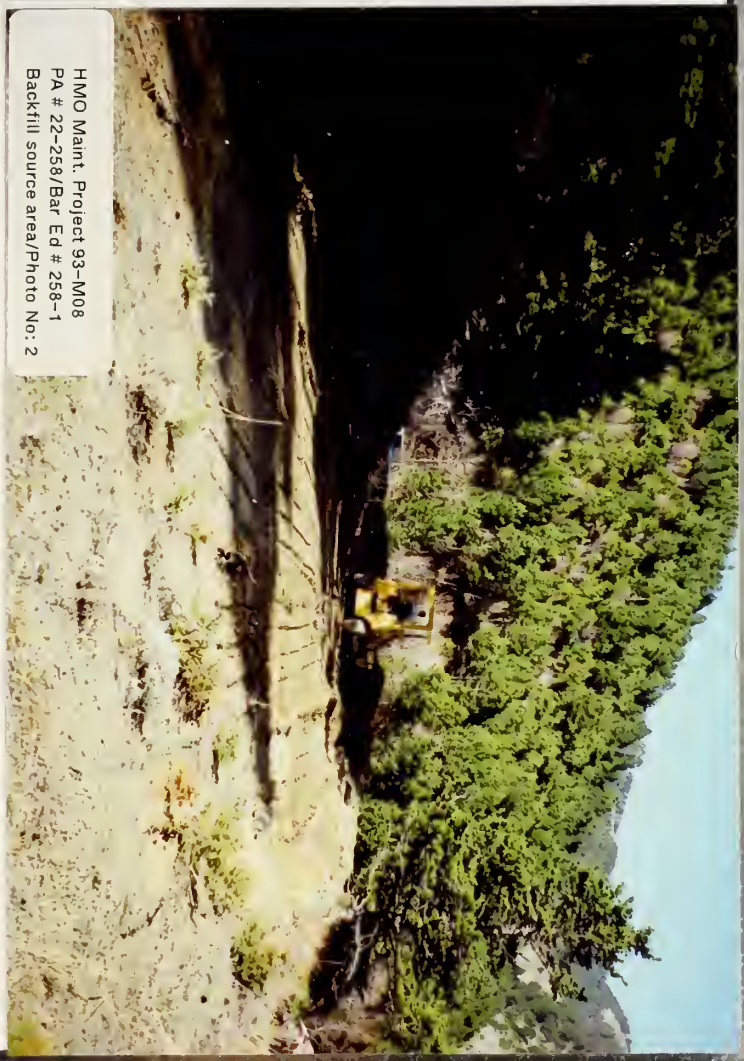
HMO Maint. Project 93-M08
PA # 22-258/Bar Ed # 258-1
Backfill source area/Photo No: 2

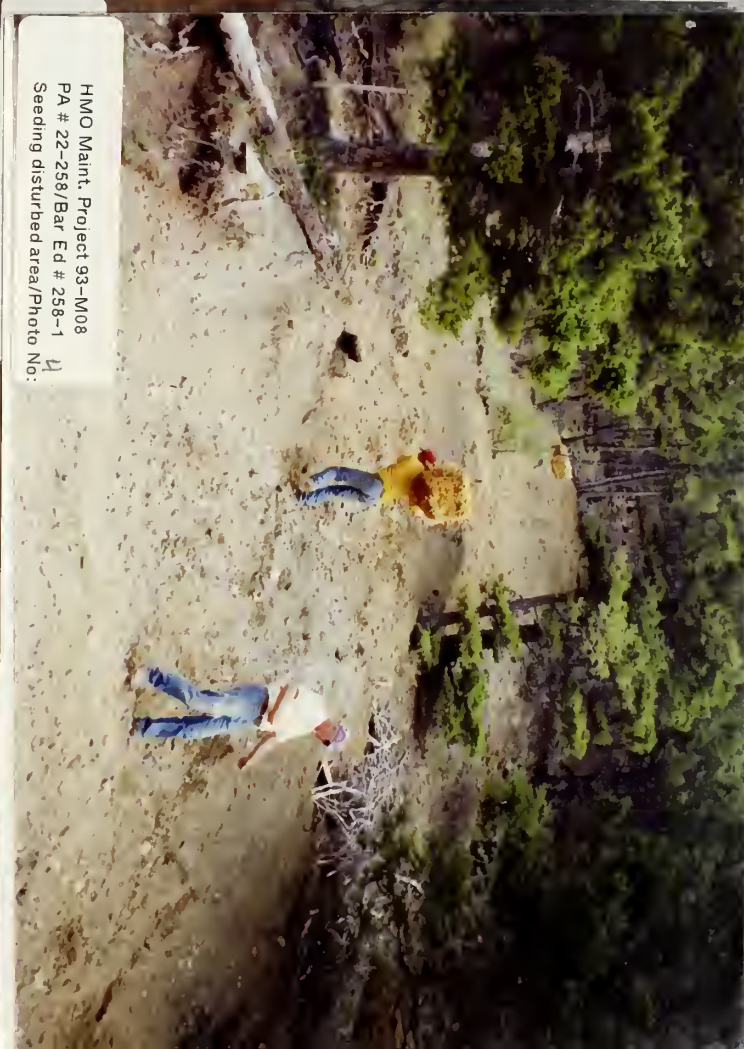
HMO Maint. Project 93-M08
PA # 22-258/Bar Ed # 258-1
Seeding disturbed area/Photo No: 4

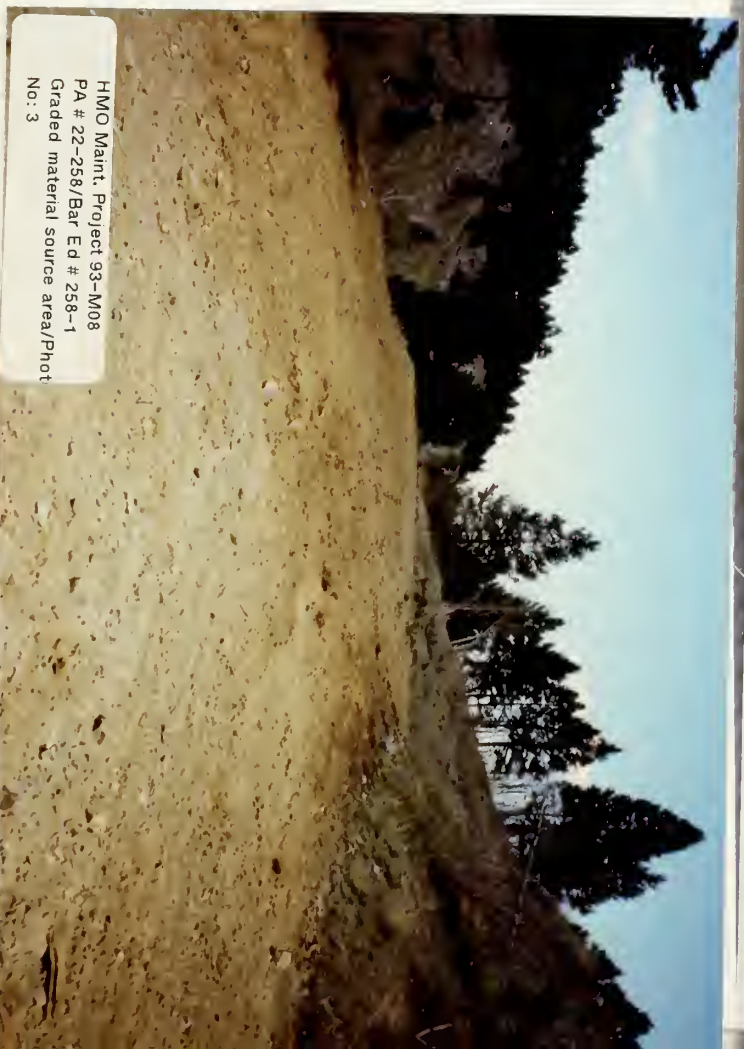
HMO Maint. Project 93-M08
PA # 22-258/Bar Ed # 258-1
Graded material source area/Photo No: 3

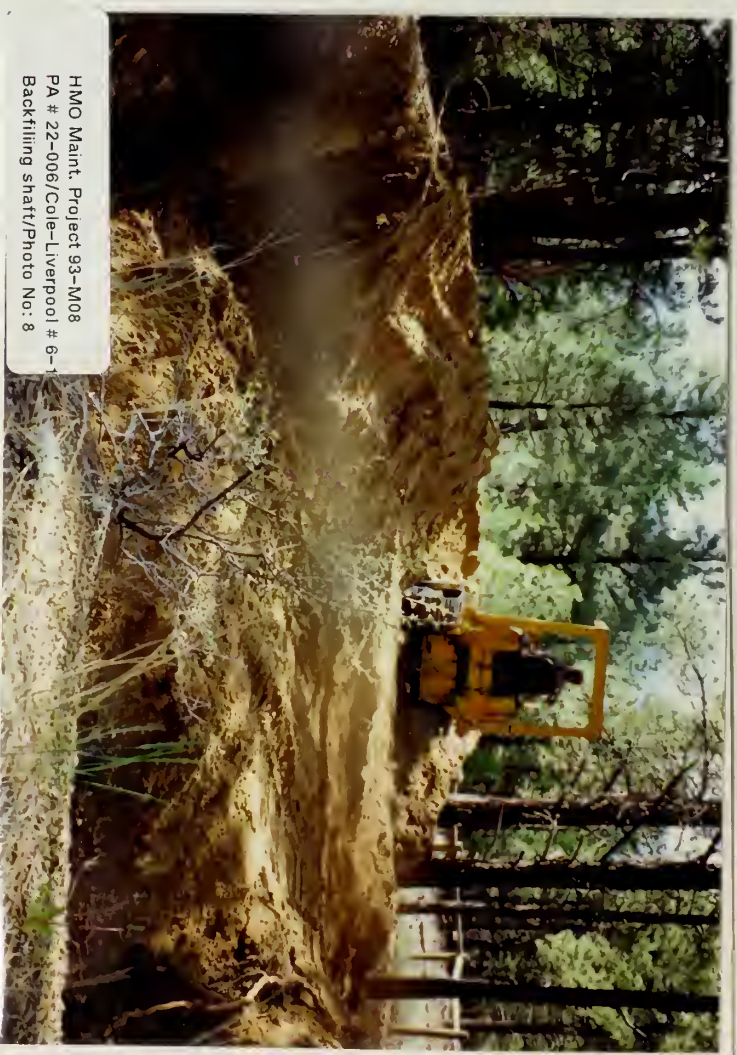
HMO Maint. Project 93-M08
PA # 22-006/Cole-Liverpool # 6-1
Backfilling shaft/Photo No: 8

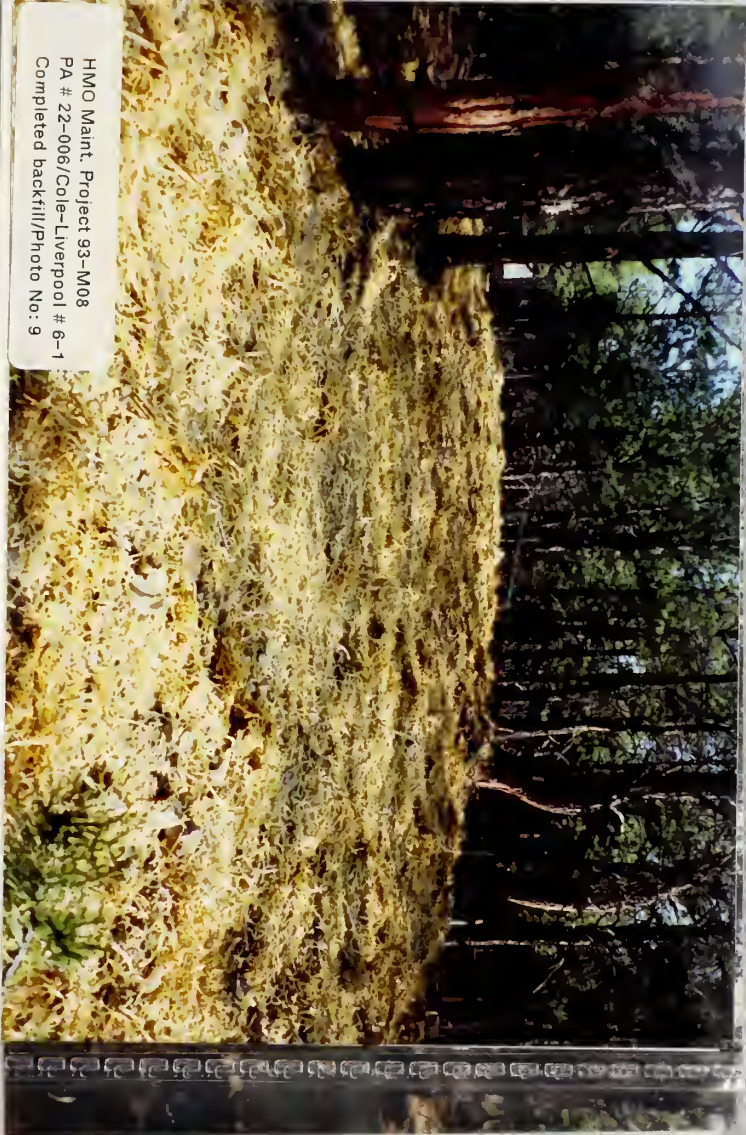
HMO Maint. Project 93-M08
PA # 22-006/Cole-Liverpool # 6-1
Completed backfill/Photo No: 9

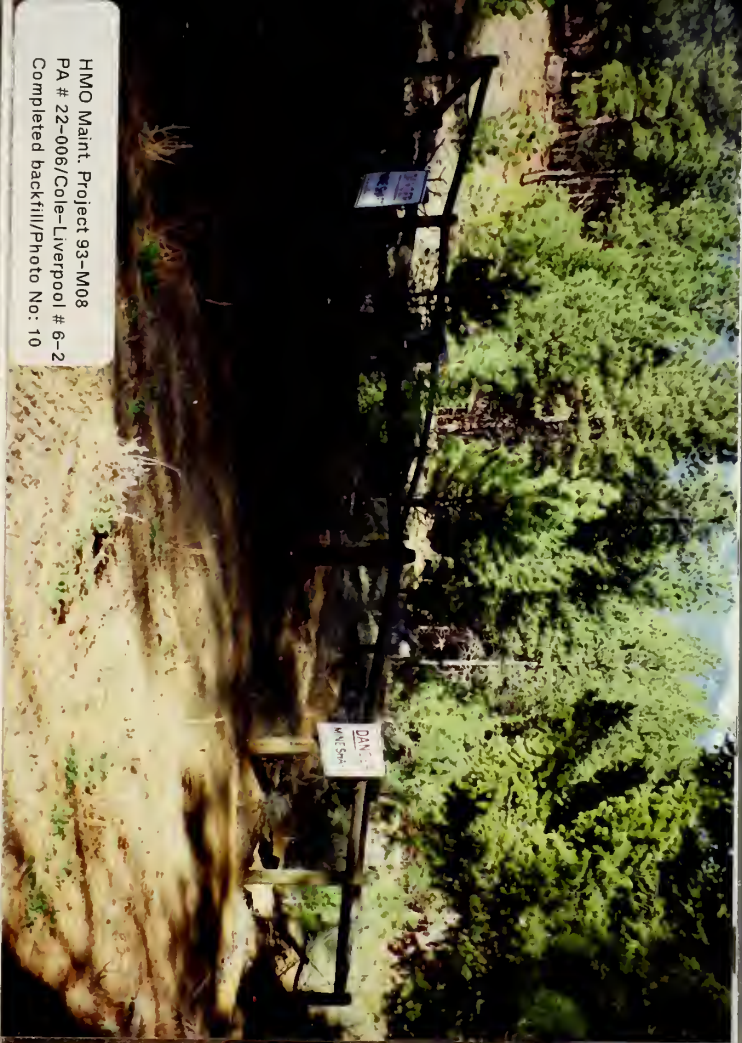
HMO Maint. Project 93-M08
PA # 22-006/Cole-Liverpool # 6-2
Completed backfill/Photo No: 10

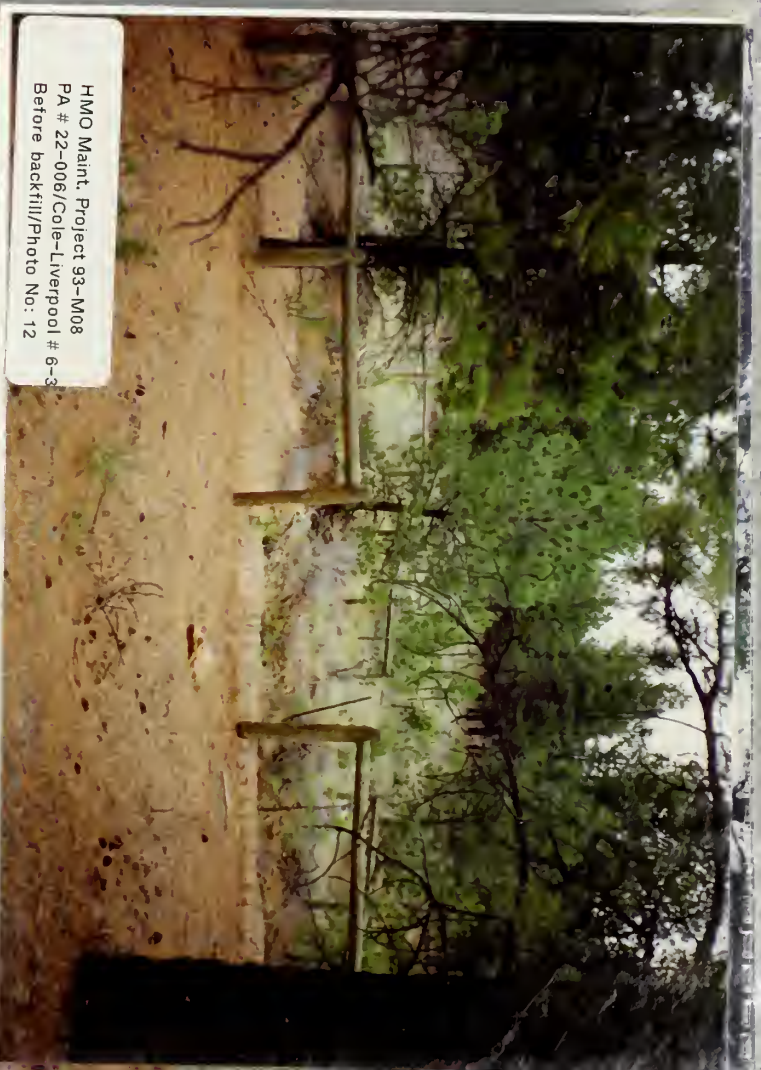
HMO Maint. Project 93-M08
PA # 22-006/Cole-Liverpool # 6-3
Before backfill/Photo No: 12

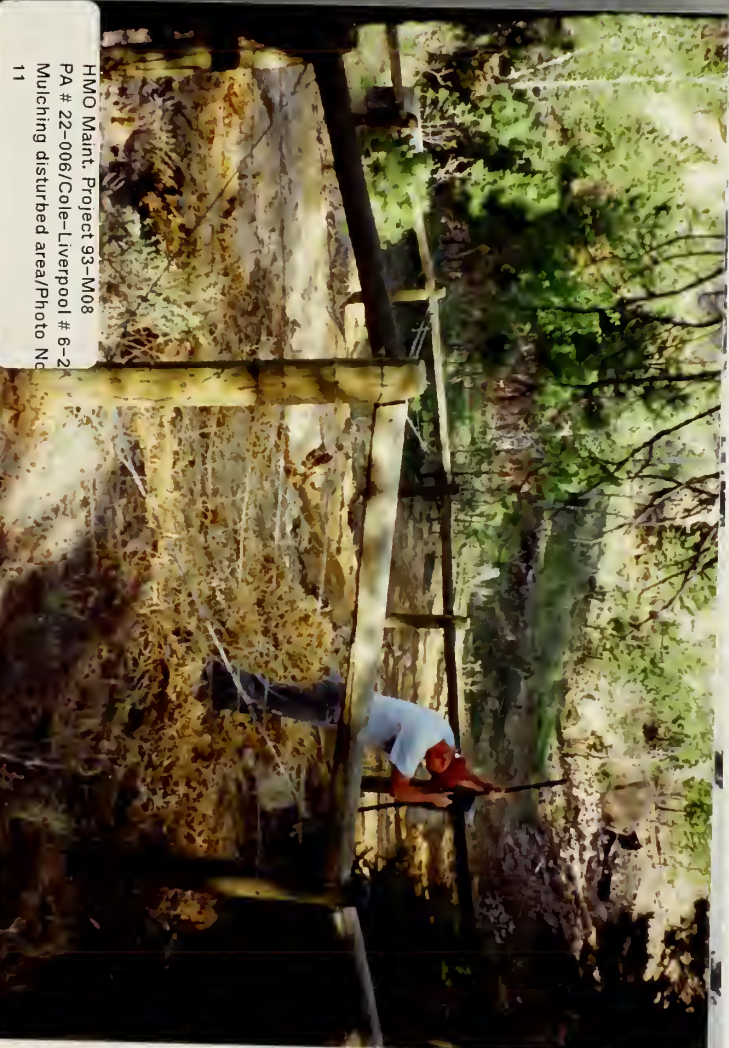
HMO Maint. Project 93-M08
PA # 22-006/Cole-Liverpool # 6-2
Mulching disturbed area/Photo No: 11

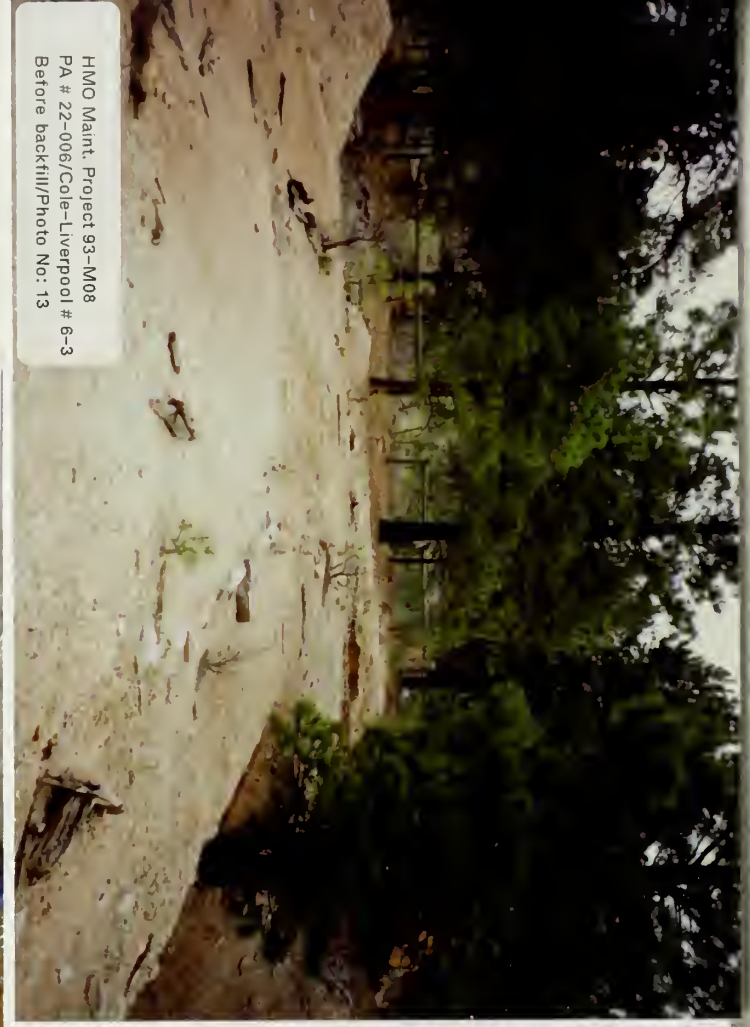
HMO Maint. Project 93-M08
PA # 22-006/Cole-Liverpool # 6-3
Before backfill/Photo No: 13

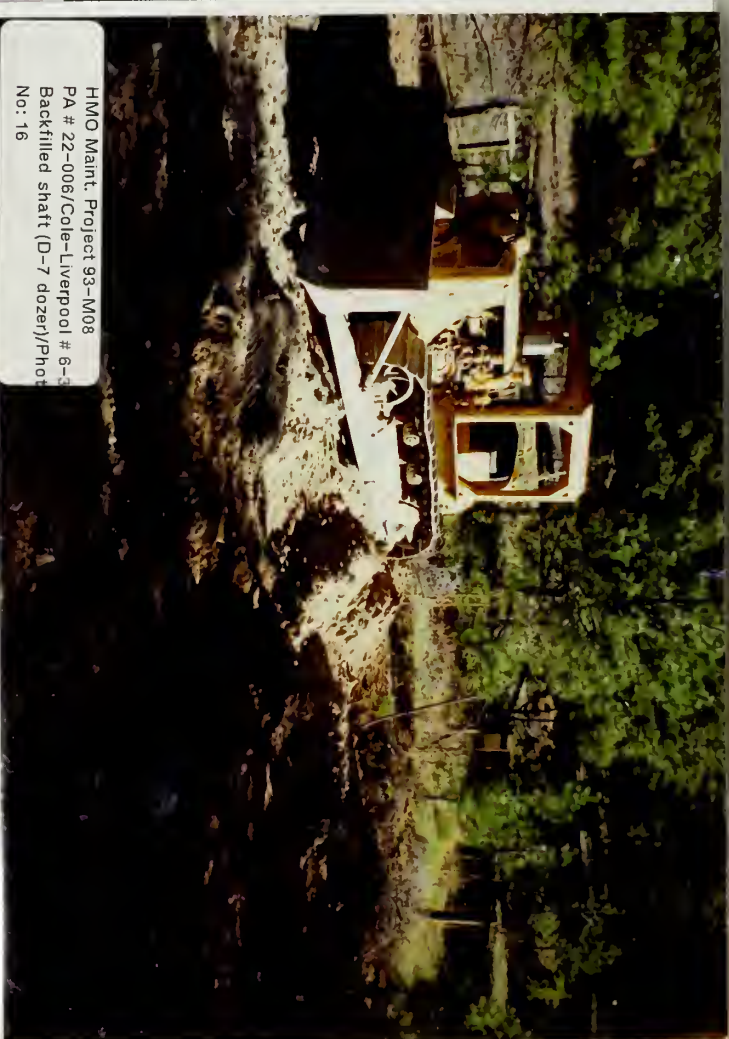
HMO Maint. Project 93-M08
PA # 22-006/Cole-Liverpool # 6-3
Backfilled shaft (D-7 dozer)/Photo
No: 16

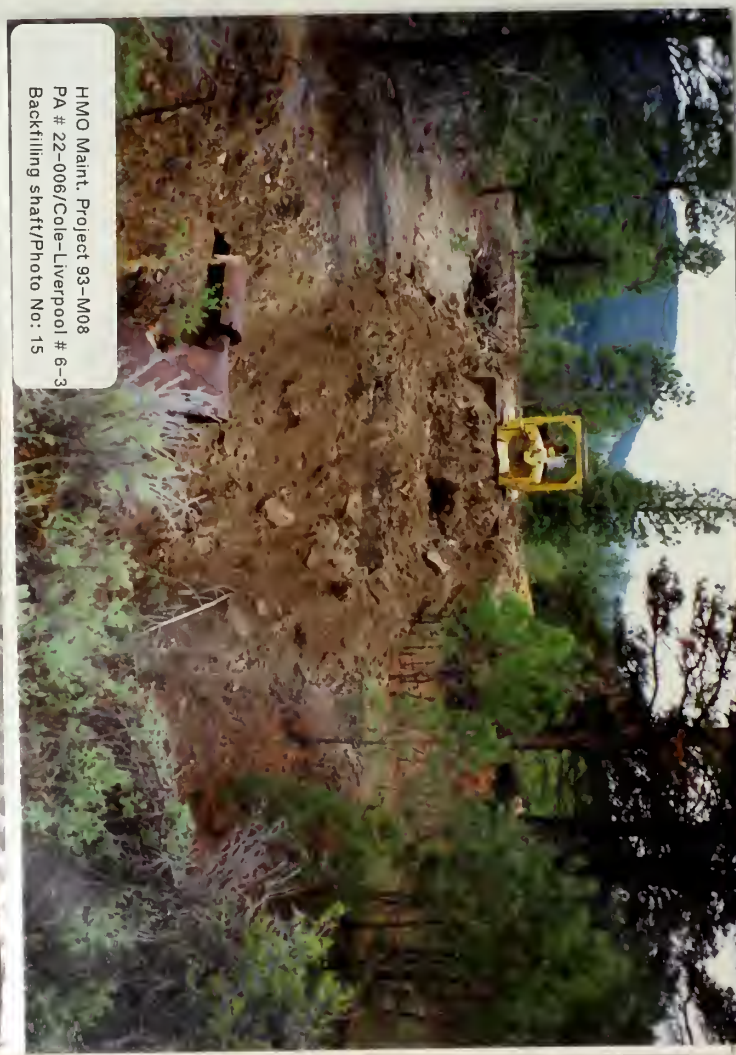
HMO Maint. Project 93-M08
PA # 22-006/Cole-Liverpool # 6-3
Backfilling shaft/Photo No: 15

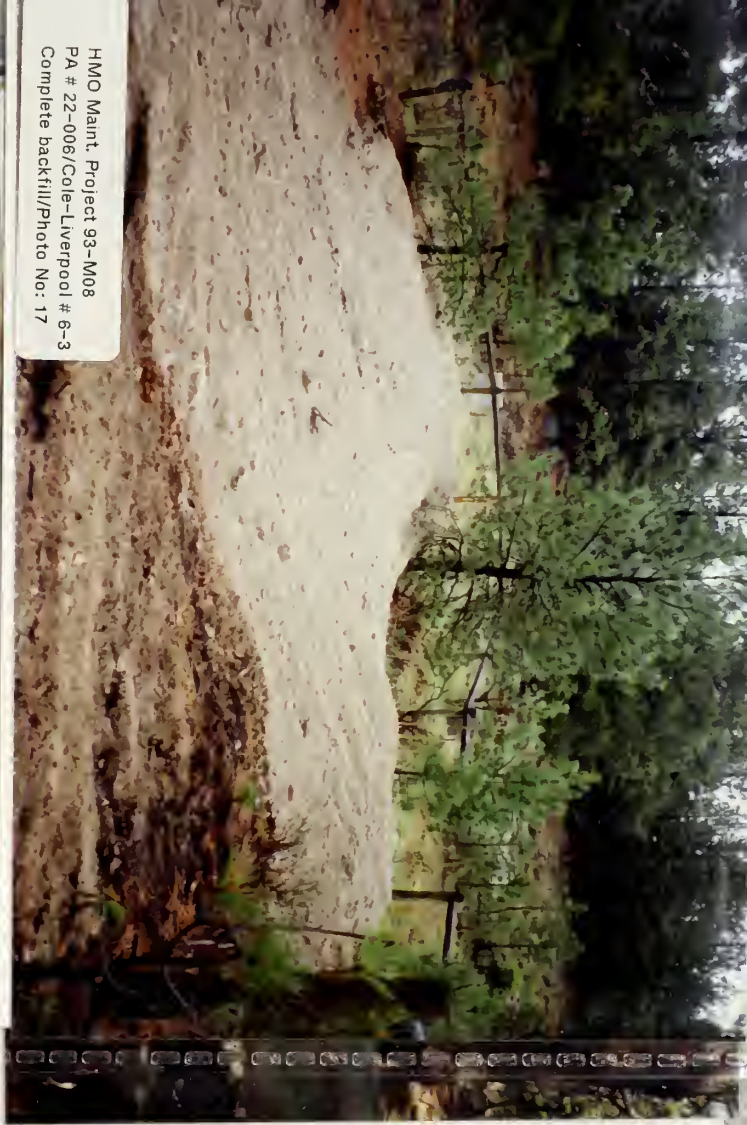
HMO Maint, Project 93-M08
PA # 22-006/Cole-Liverpool # 6-3
Complete backfill/Photo No: 17

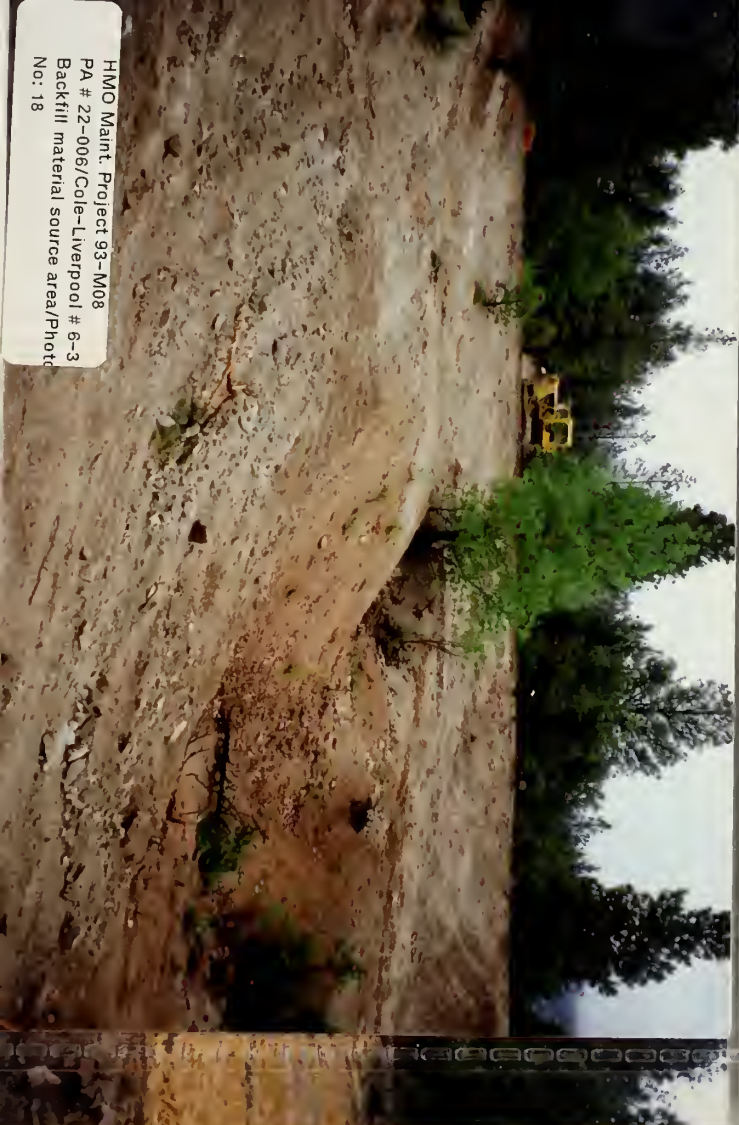
HMO Maint, Project 93-M08
PA # 22-006/Cole-Liverpool # 6-3
Backfill material source area/Photo
No: 18

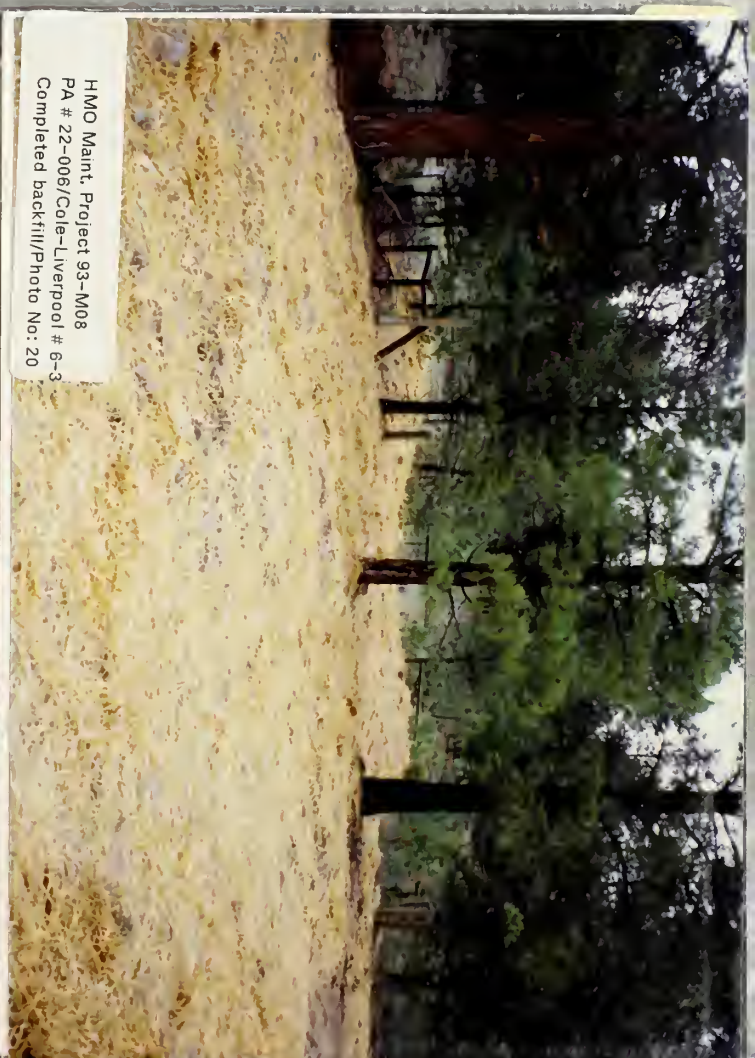
HMO Maint, Project 93-M08
PA # 22-006/Cole-Liverpool # 6-3
Completed backfill/Photo No: 20

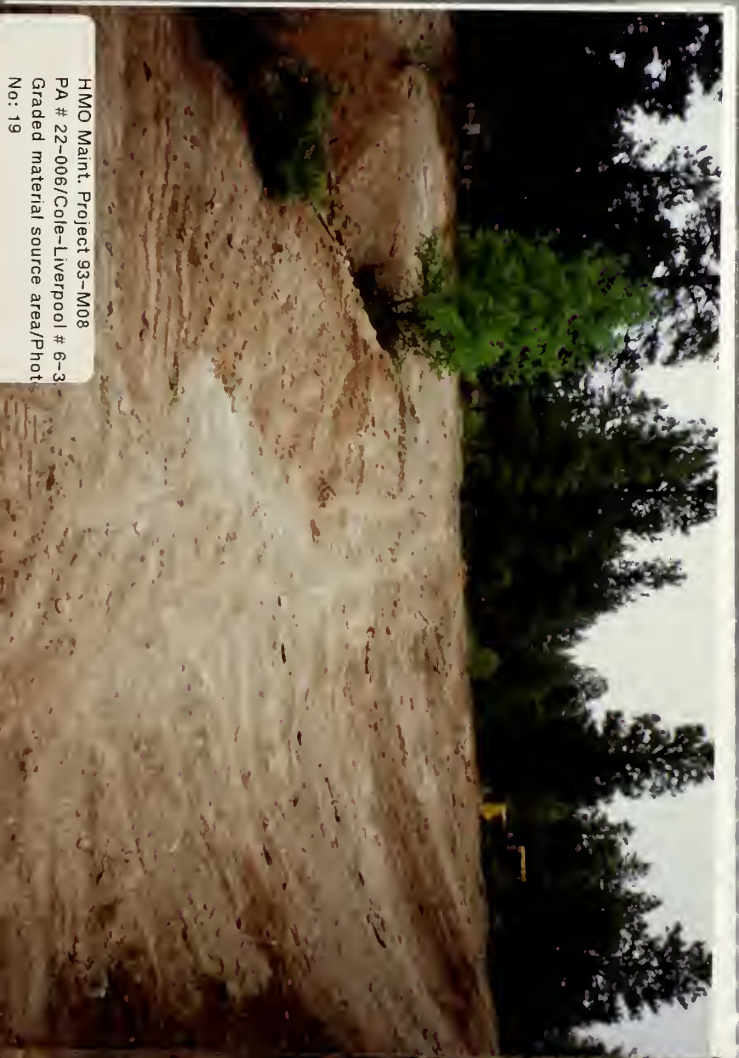
HMO Maint, Project 93-M08
PA # 22-006/Cole-Liverpool # 6-3
Graded material source area/Photo
No: 19

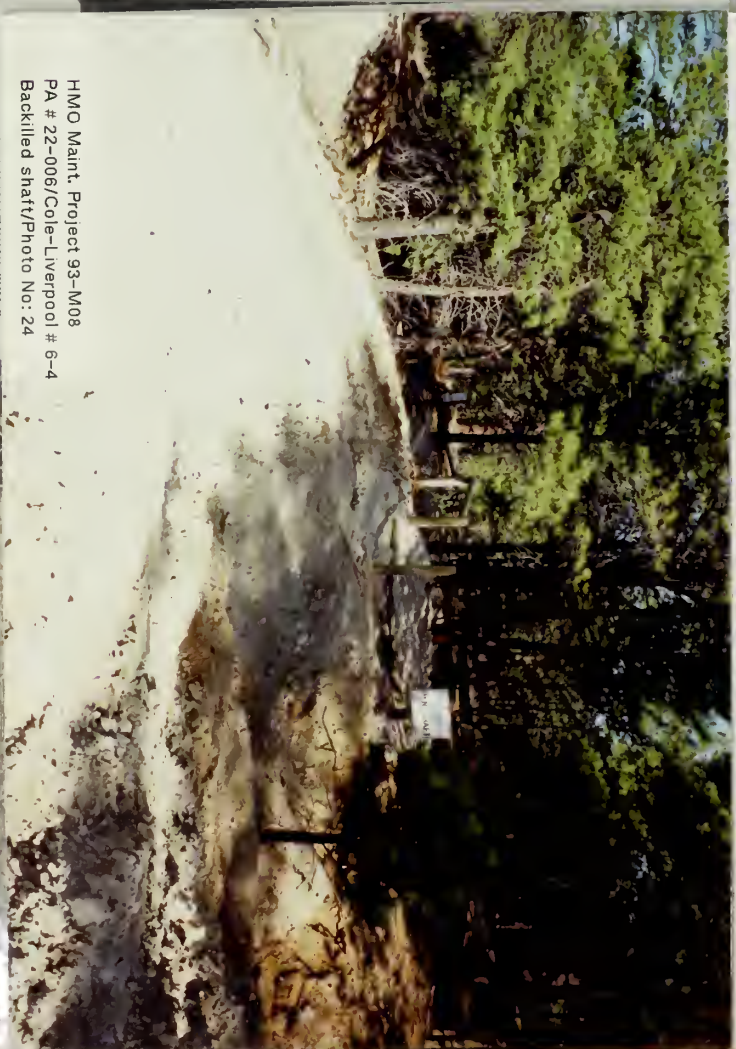
HMO Maint, Project 93-M08
PA # 22-006/Cole-Liverpool # 6-4
Backfilled shaft/Photo No: 24
Backfilling shaft/Photo No: 25

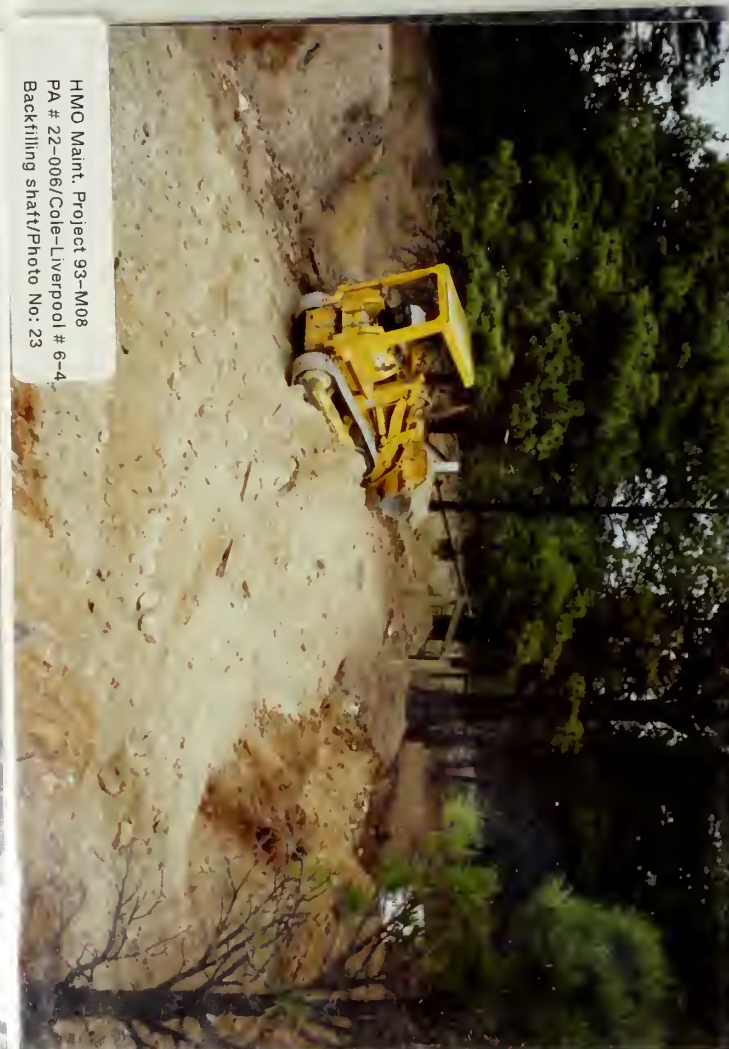
HMO Maint, Project 93-M08
PA # 22-006/Cole-Liverpool # 6-4
Backfilling shaft/Photo No: 23

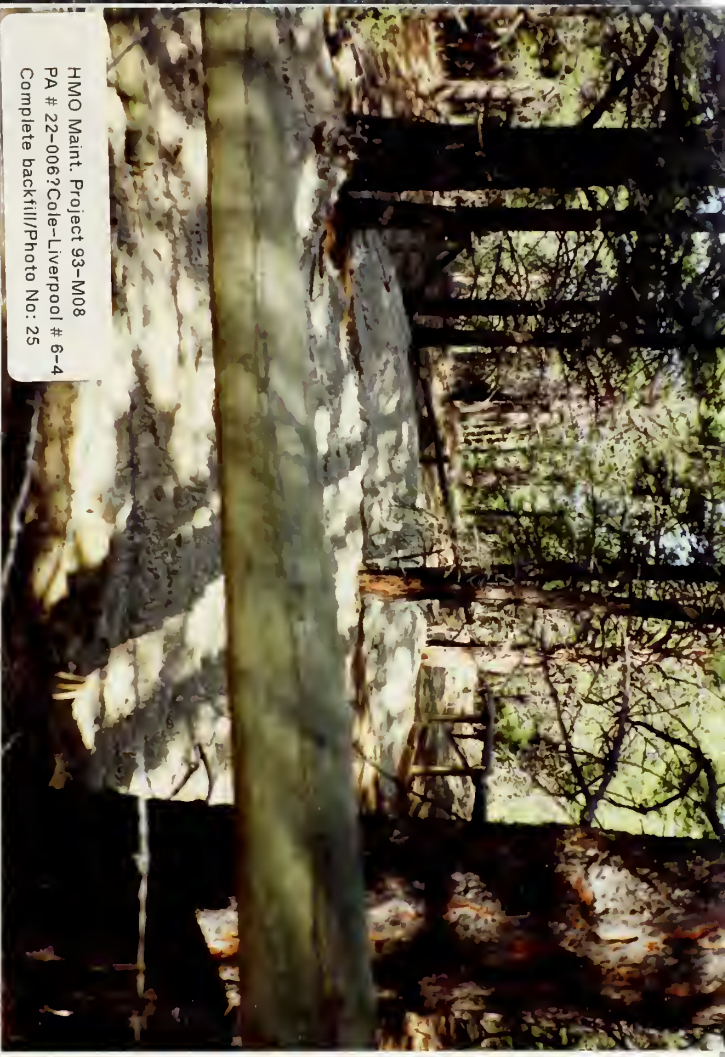
HMO Maint. Project 93-M08
PA # 22-006?Cole-Liverpool # 6-4
Complete backfill/Photo No: 25

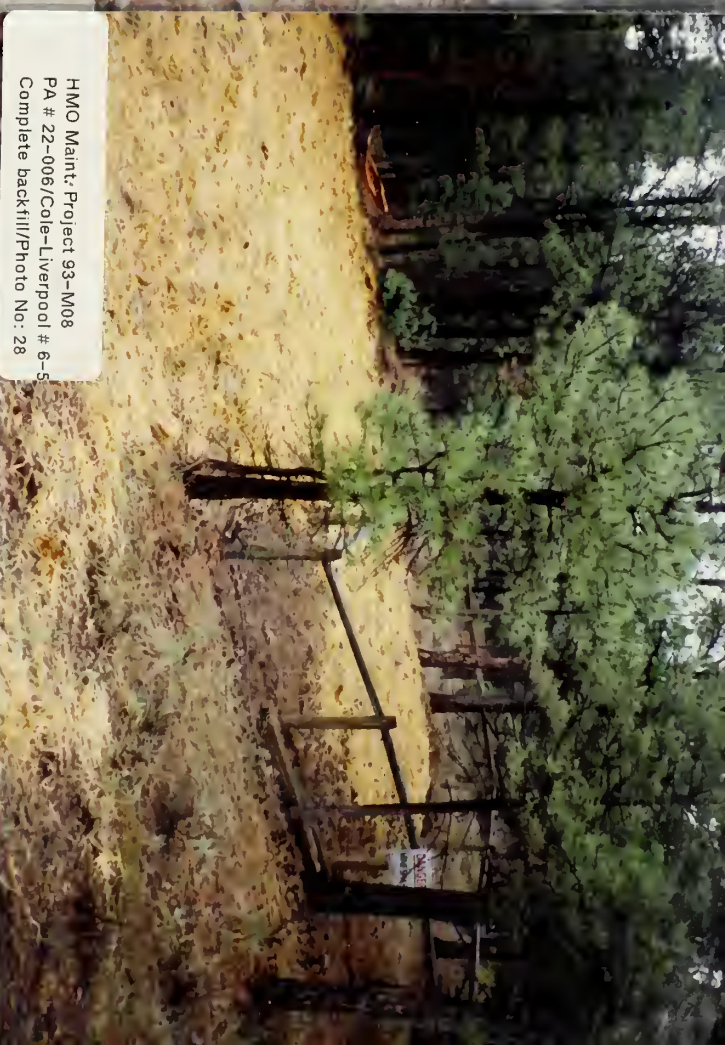
HMO Maint. Project 93-M08
PA # 22-006/Cole-Liverpool # 6-5
Complete backfill/Photo No: 28

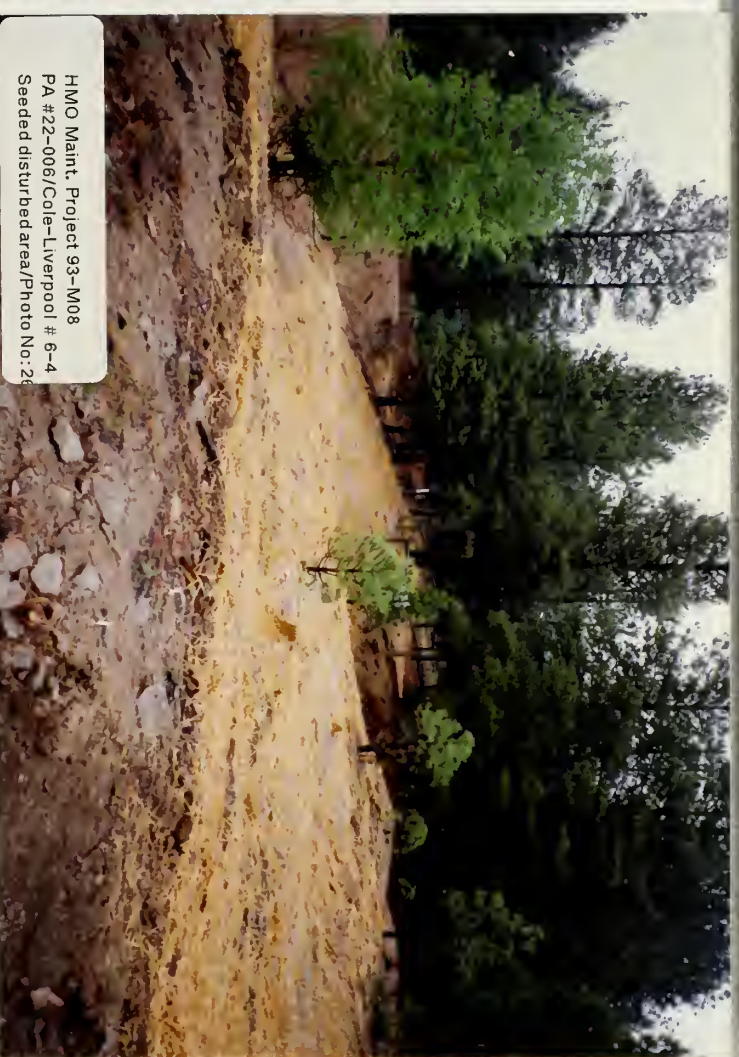
HMO Maint. Project 93-M08
PA #22-006/Cole-Liverpool # 6-4
Seeded disturbed area/Photo No: 26

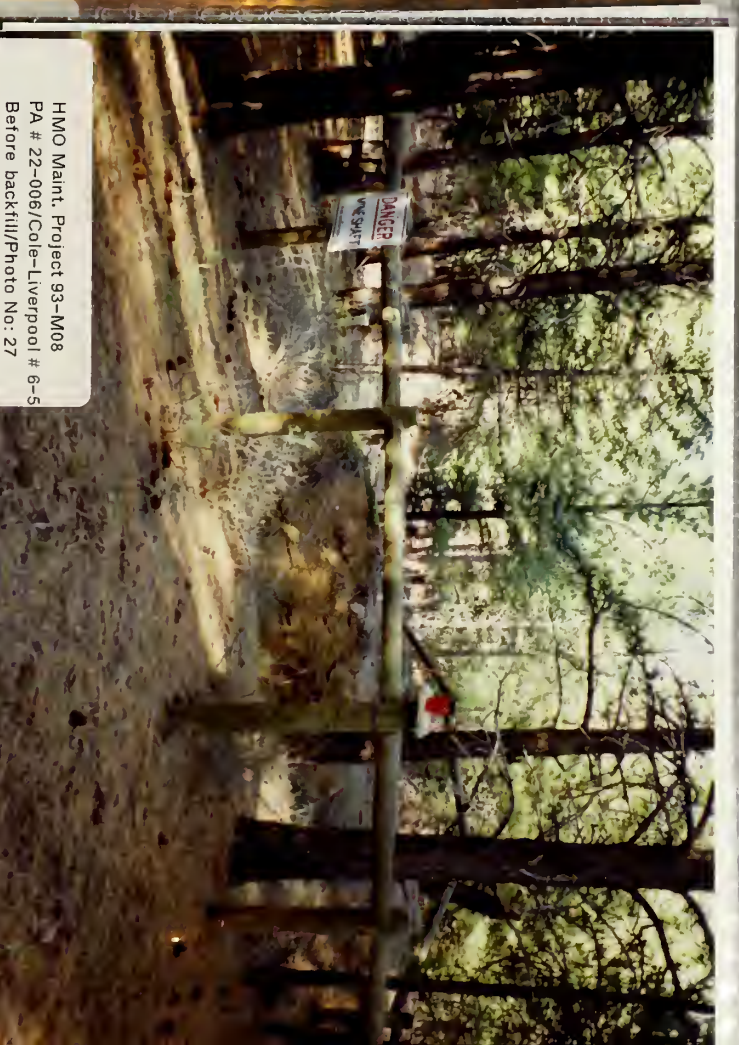
HMO Maint. Project 93-M08
PA # 22-006/Cole-Liverpool # 6-5
Before backfill/Photo No: 27

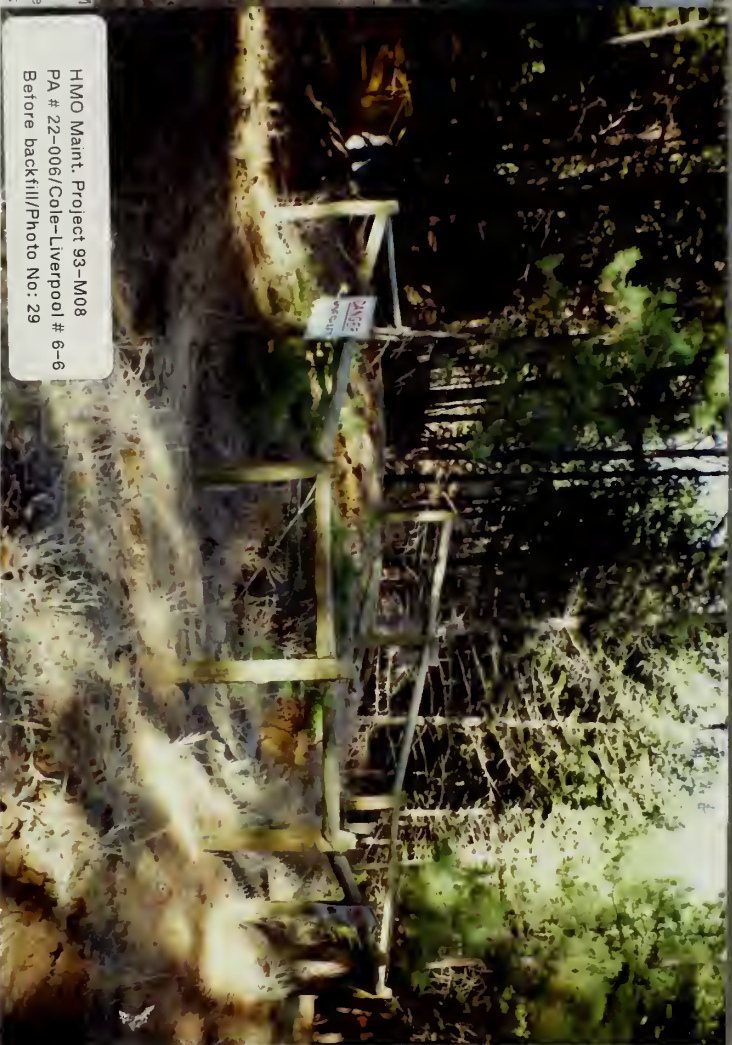
HMO Maint. Project 93-M08
PA # 22-006/Cole-Liverpool # 6-6
Before backfill/Photo No: 29

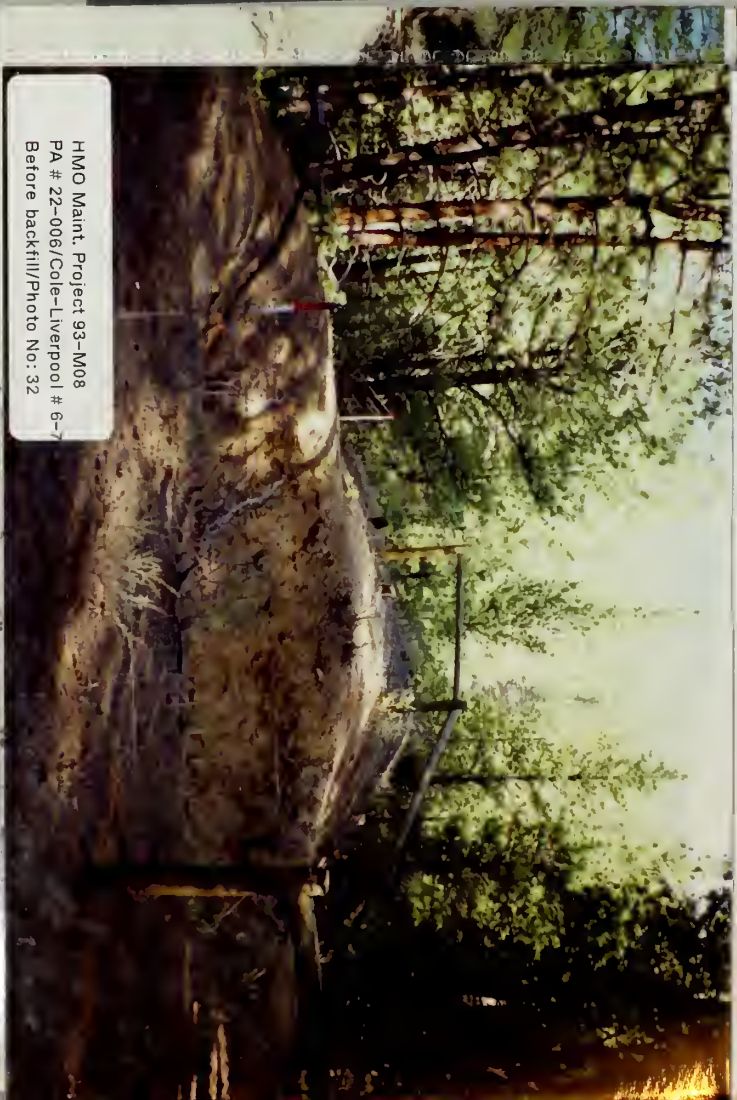
HMO Maint. Project 93-M08
PA # 22-006/Cole-Liverpool # 6-7
Before backfill/Photo No: 32

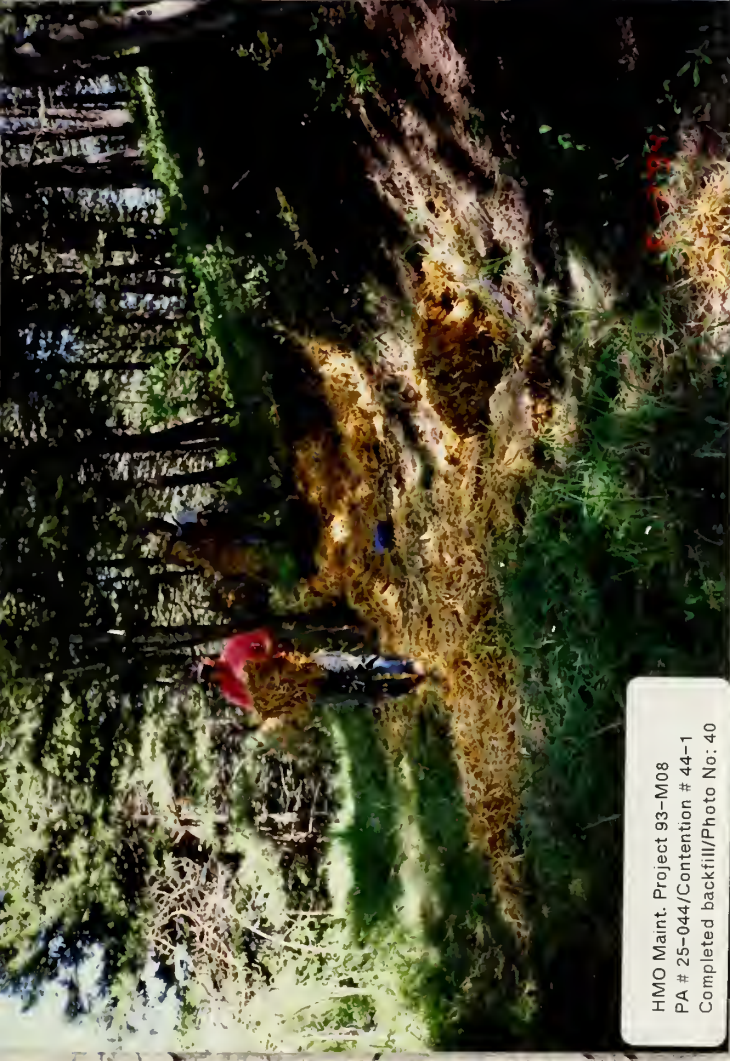
HMO Maint. Project 93-M08
PA # 25-044/Contention # 44-1
Completed backfill/Photo No: 40

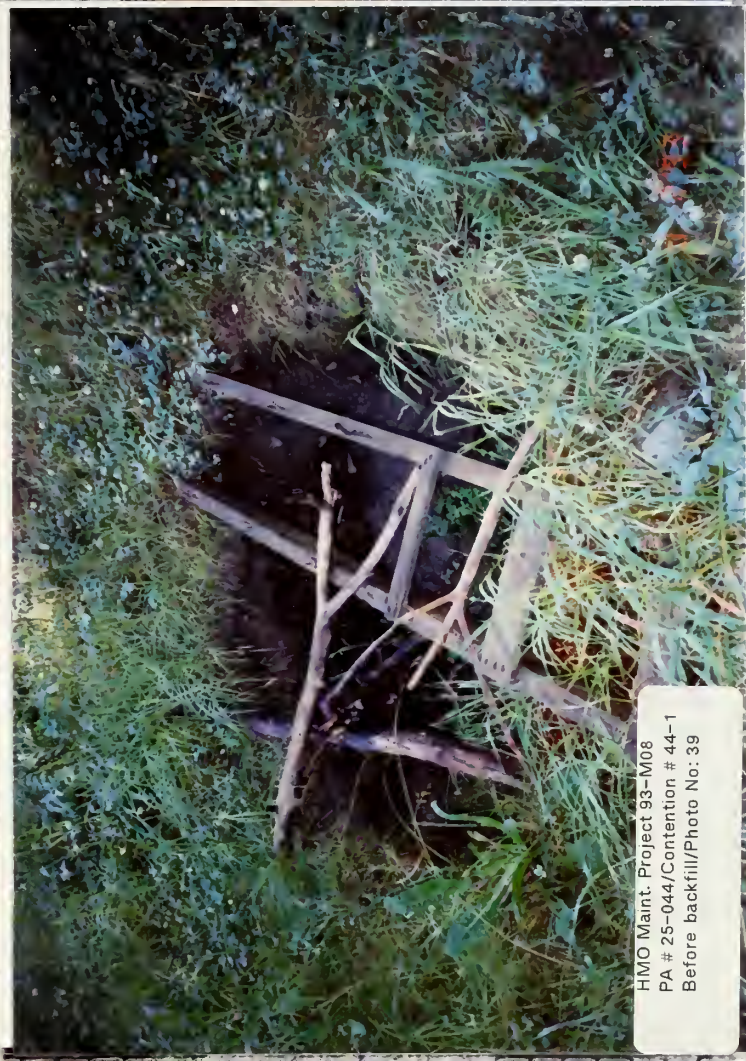
HMO Maint. Project 93-M08
PA # 25-044/Contention # 44-1
Before backfill/Photo No: 39

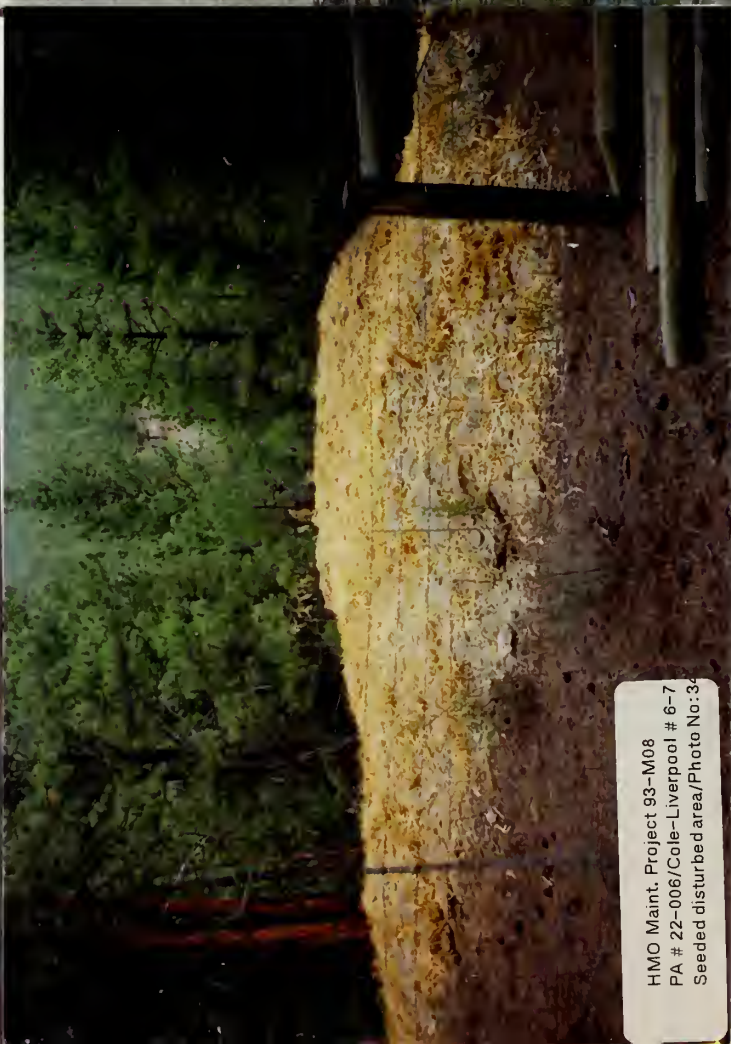
HMO Maint. Project 93-M08
PA # 22-006/Cole-Liverpool # 6-7
Seeded disturbed area/Photo No: 34

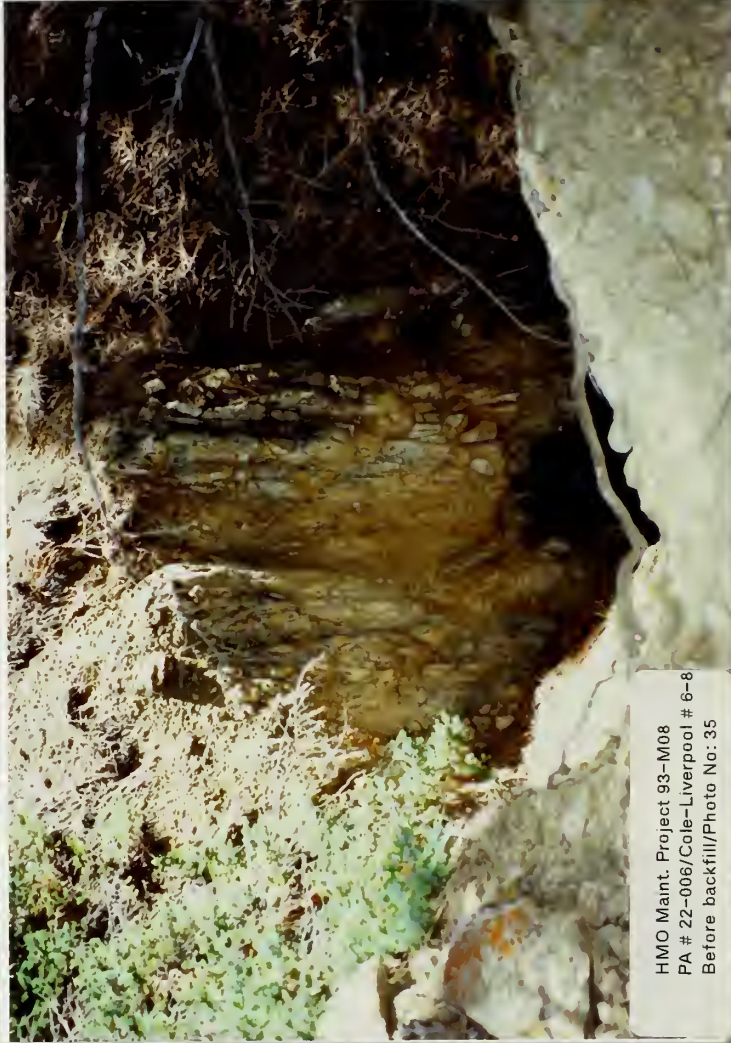
HMO Maint. Project 93-M08
PA # 22-006/Cole-Liverpool # 6-8
Before backfill/Photo No: 35
